MECHANICAL STABILITY OF RETAINED AUSTENITE IN TEMPERED 9NI STEEL

C. K. Syn, B. Fultz and J. W. Morris, Jr.

Technical Report No. 7
Office of Naval Research
Contract No. N00014-75-C-0154

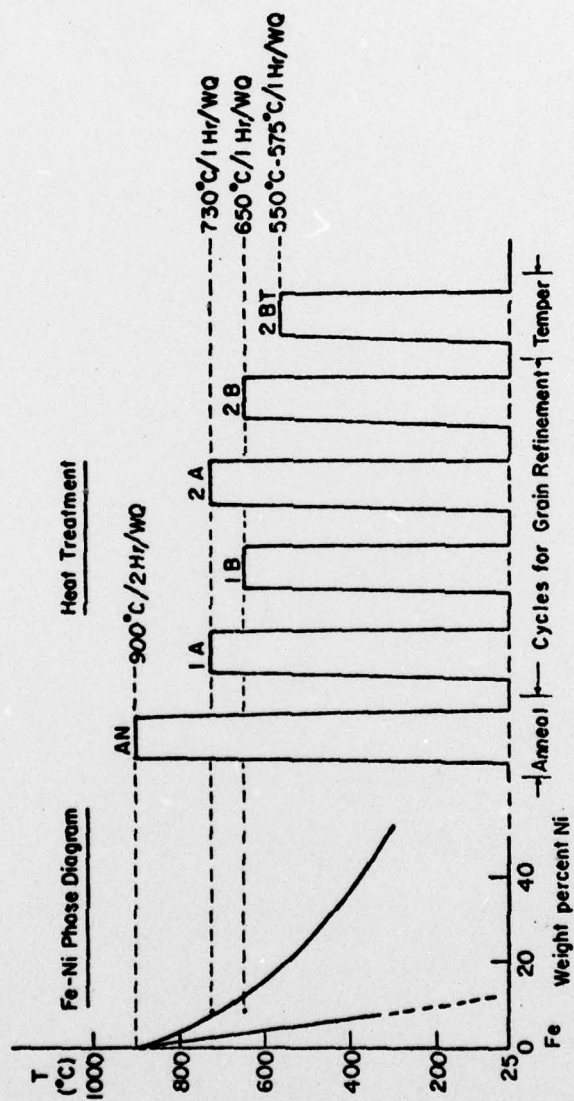
FIG. 2

- FIG. 2. Thermal cycling and temper procedure for grain refinement in 9Ni steel.
- FIG. 3. Scanning electron microscopic (SEM) fractograph. Tempered ($575^{\circ}\text{C}/1$ hour/water quench) after grain-refinement and fractured in the compact tension test at 77K. K_{IC} estimated to be $300 \text{ ksi}\sqrt{\text{in}}$ ($330 \text{ MPa}\sqrt{\text{m}}$).

A 9Ni steel plate of 30mm thickness was supplied by the Nippon Steel Corporation. Its chemical composition is given in Table I. Compact tension fracture toughness specimens were cut out of the plate. To insure that these specimens would fail in a ductile manner at 77°K the as-received microstructure was erased by annealing at 900°C for two hours, and the specimens were given the grain refinement treatment shown in Figure 2. After grain refinement the specimens were tempered at 575°C for one hour and water quenched. The final microstructure of the specimens is illustrated in Figure 1. Previous work¹¹ has shown that this grain refinement plus tempering treatment suffices to reduce the ductile-to-brittle transition temperature of 9Ni steel to below 6°K. Fracture toughness tests were conducted on these specimens in liquid nitrogen (77°K) with the result that the specimens failed in a ductile manner (Figure 3) with a fracture toughness (K_{IC}) estimated to exceed 300 ksi \sqrt{in} (330 MPa \sqrt{m}), in agreement with earlier results.

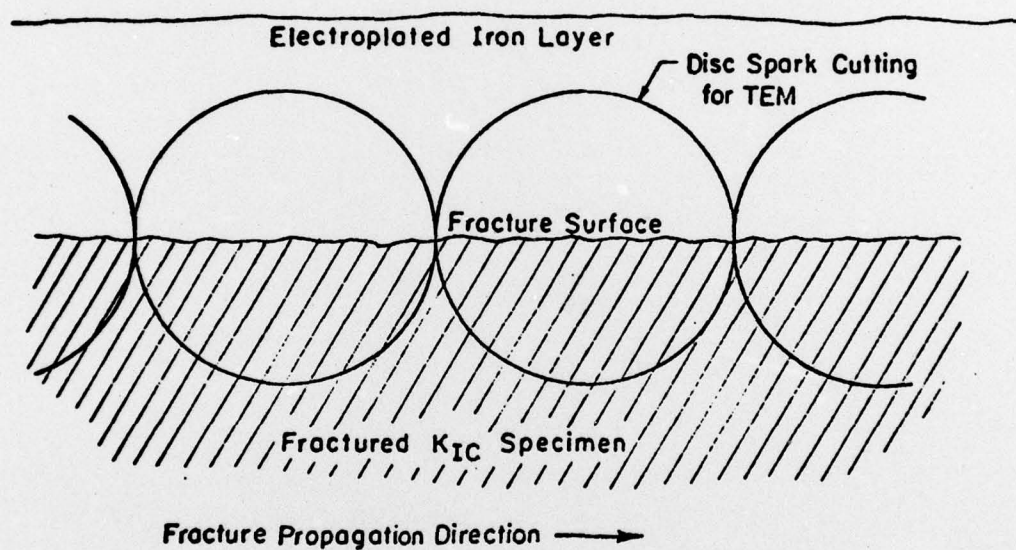
FIG. 4

- FIG. 4. Schematic diagram of disc preparation from the boundary area between the fractured 9Ni steel and the electroplated iron layer.
- FIG. 5. Conversion electron Mössbauer spectra from the fracture surfaces. Solid curves were hand-drawn through datum points.

One of the two matching parts of a specimen fractured at 77°K was used for Mössbauer spectroscopy. The fracture surface of the other piece was electroplated with pure iron to a thickness of more than 2mm using the Fischer-Langbein type solution.¹² The plated piece was sliced along the direction of the fracture crack propagation and perpendicular to the fracture surface. Three slices, ~500µm thick, were chemically and mechanically thinned to a thickness of ~40µm. Discs of 3mm diameter were then spark cut from the slices in such a way that the boundary lines between the plated iron layer and the fractured 9Ni steel lay approximately along a diameter of the disc (Figure 4).

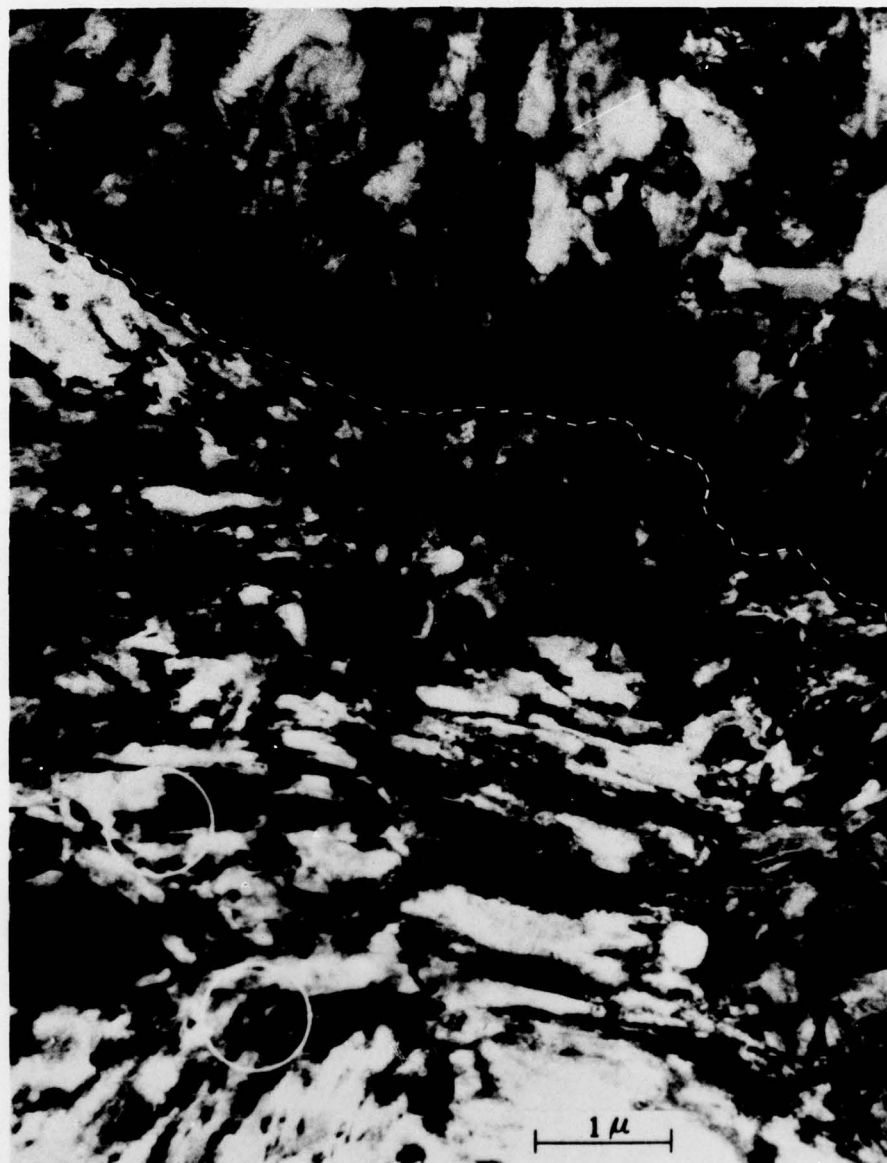
FIG. 6

- FIG. 6. Transmission electron micrograph and diffraction pattern of the fracture surface layer. The boundary between the electroplated iron layer (above) and fractured 9Ni steel (below) was marked by a dashed line. The diffraction pattern was taken from the central region right below the boundary line. The circled area shows retained austenite-like particles.

The profile fractographic samples prepared for this study permitted examination of the region below the fracture surface to a depth of $\sim 20\mu\text{m}$ in a transmission electron microscope operated at 650 KeV . Typical bright field micrographs are shown in Figures 6 and 7. The fracture surface is easily located by the abrupt change in microstructure between the electroplated iron layer (above) and the deformed 9Ni steel (below) and is marked with arrows and a dashed line respectively. The severe deformation of the alloy immediately below the fracture surface is visually apparent. Figure 6 includes a selected area diffraction

pattern taken from the central region of the micrograph immediately below the fracture surface. The spread of the diffraction spots along each diffraction ring is indicative of the severe deformation of the subsurface material; as shown in Figure 1 the selected area diffraction from the undeformed material yields a well-defined spot pattern. No extra spots attributable to retained austenite are present in the diffraction pattern.

The TEM evidence argues, however, that the transformation of the austenite is in this case to a dislocated martensite rather than to a twinned martensite as suggested by earlier work.⁸ In a careful structural survey of the subsurface region no example of internally twinned martensite was found. In particular, the martensite particles which were tentatively identified as transformed austenite on morphological grounds were dislocated rather than twinned. Examples include the circled regions in Figure 6.

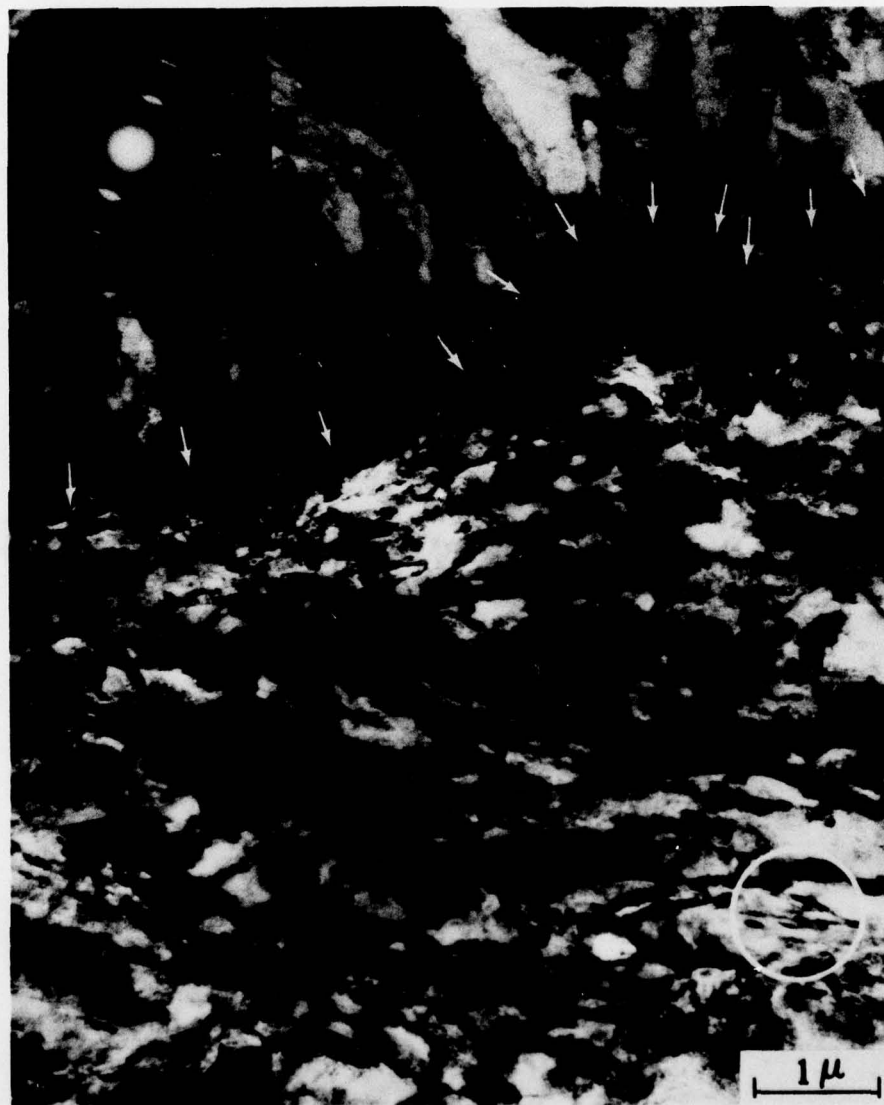
FIG. 7

- FIG. 7. Another TEM picture of the fracture surface layer (the boundary indicated by arrows). The circled areas show retained austenite-like particles.

A careful survey of the deformed region below the fracture surface to a depth of $\sim 20\mu\text{m}$ yielded no diffraction evidence for retained austenite, despite the fact that features which morphologically resemble the retained austenite present in the undeformed alloy are common. Examples of γ -like features are circled in Figures 6 and 7; they are comparable to the retained austenite particles present in the dark field micrograph in Figure 1. The TEM study hence supports the conclusion from Mössbauer analysis that there is complete transformation of the austenite near the fracture surface.
